# Composites Part B

# Toughening of brittle polyester with functionalized halloysite nanocomposites

M.T. Albdiry<sup>a,\*</sup>, B.F. Yousif<sup>b</sup>

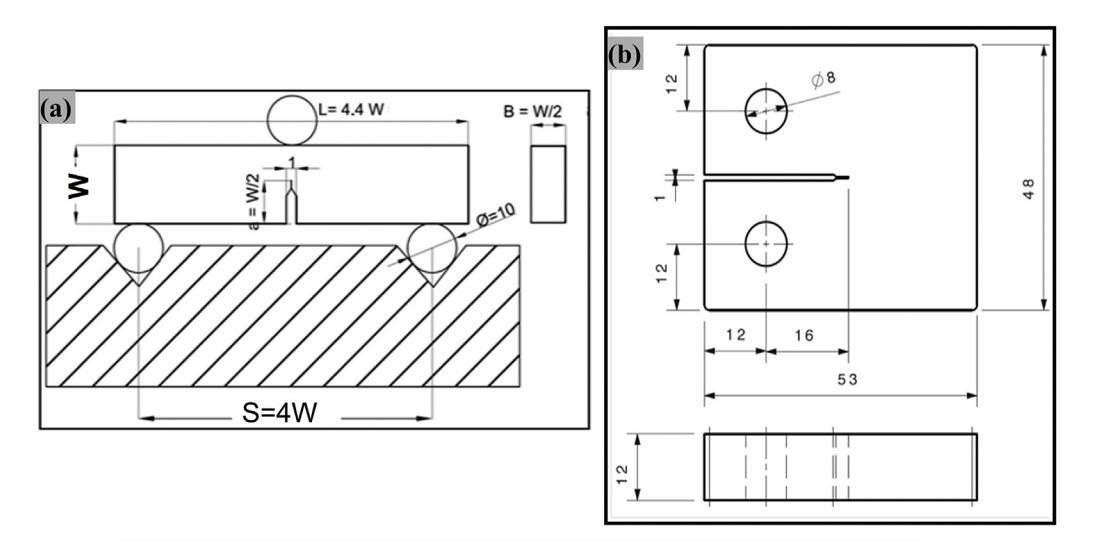
Fig. 1. Specimen configuration as used for fracture toughness measurements (a) SENB sample, and (b) CT geometry.

In this study, values of fracture toughness are measured following the linear elastic fracture mechanics (LEFM) described in ASTM D 5045 [18]. Two common testing geometries, single-edge notch bending (SENB) and compact tension (CT) configuration are applied. The SENB geometry is more popular because it requires less material without complicated machining compared to the CT sample geometry. The CT geometry gives more accurate plain-strain fracture toughness since it gives more space for the crack propagation. The SENB and CT configurations are illustrated in Fig. 1. For the both test geometries, a precrack was generated by tapping a fresh razor blade into the notch tip with a drop weight to maintain an accurate fracture toughness values. The crack length-to-width ratio (a/w) is limited to 0.5 and loading rate of 5 mm/min. In case of SENB specimen, the span-to-specimen width ratio (s/w) is maintained of 4, loaded in three-point bending (3PB).

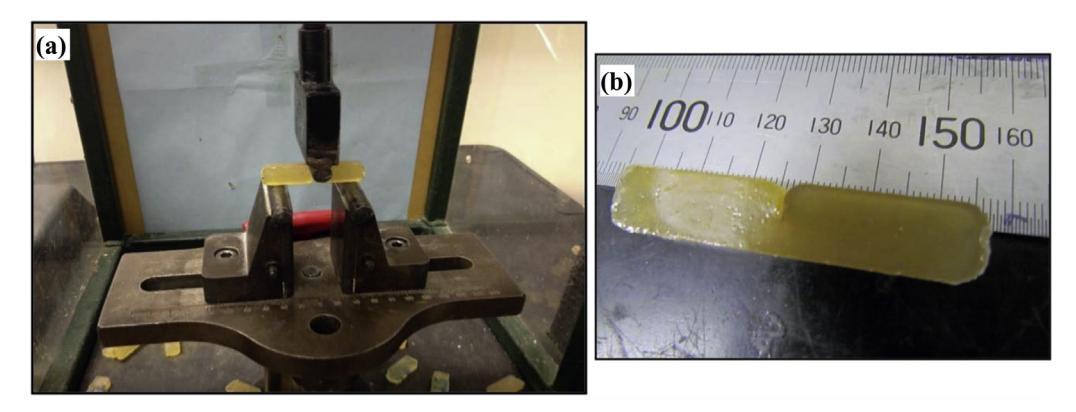
Fig. 2. Bending rig (a) and single-edge notch bend geometry (b) used in this study.

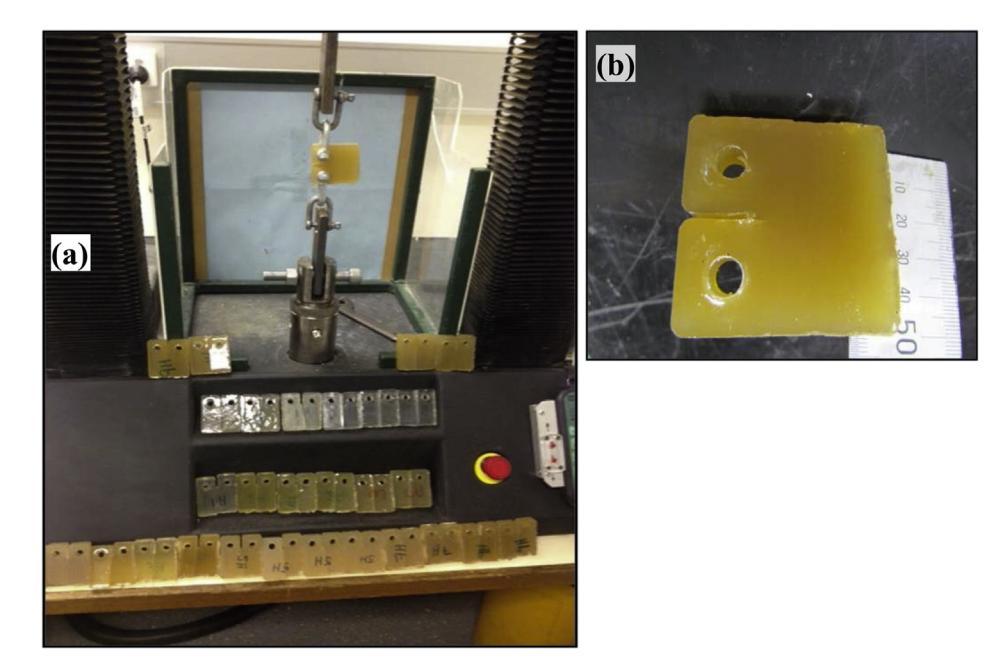
Fig. 3. (a) Tension test and clevis design used for compact tension (CT) geometry (b).

For the determination of fracture toughness measurements of neat UPE and its different nanocomposites using compact tension (CT) geometry, the tension-testing clevis and set up the test fixture (Fig. 3). Both ends of the CT specimen (Fig. 3 b) are held by special clevises and loaded through pins to provide rolling contact between the loading pins and the clevis holes. Afterwards, the CT specimen was loaded at rate of 5 mm/min. The measurement of critical strain energy release rate ( $G_{Ic}$ )

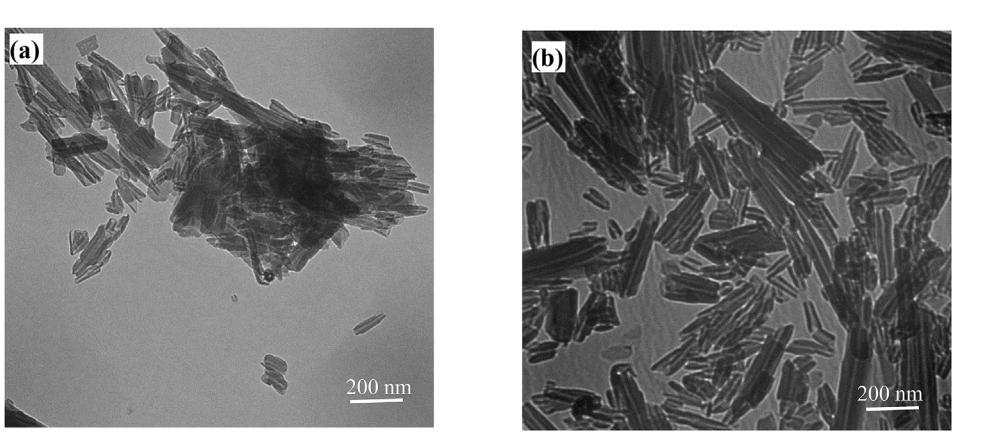
Fig. 4. TEM images of untreated halloysite nanotubes (a), and silane-treated halloysite nanotubes (b).

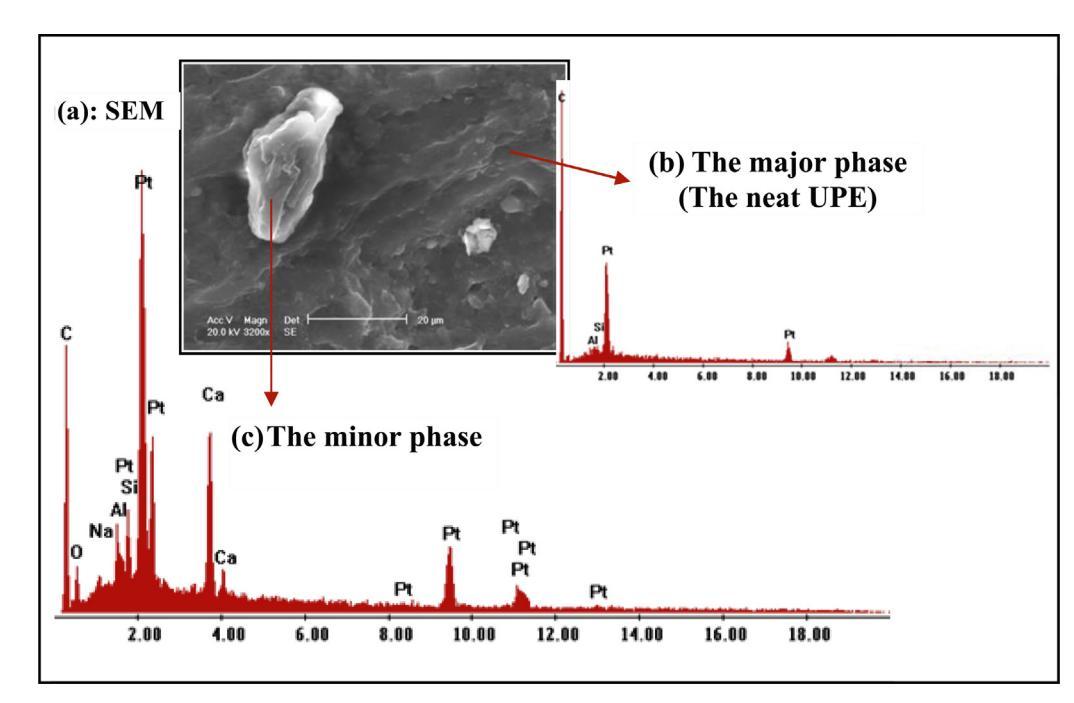
Fig. 5. (a) SEM image of UPE/5% HNTs showing large clusters, (b) and (c) observing the energy dispersive X-ray (EDX) elemental analysis for different spots in the nanocomposite.

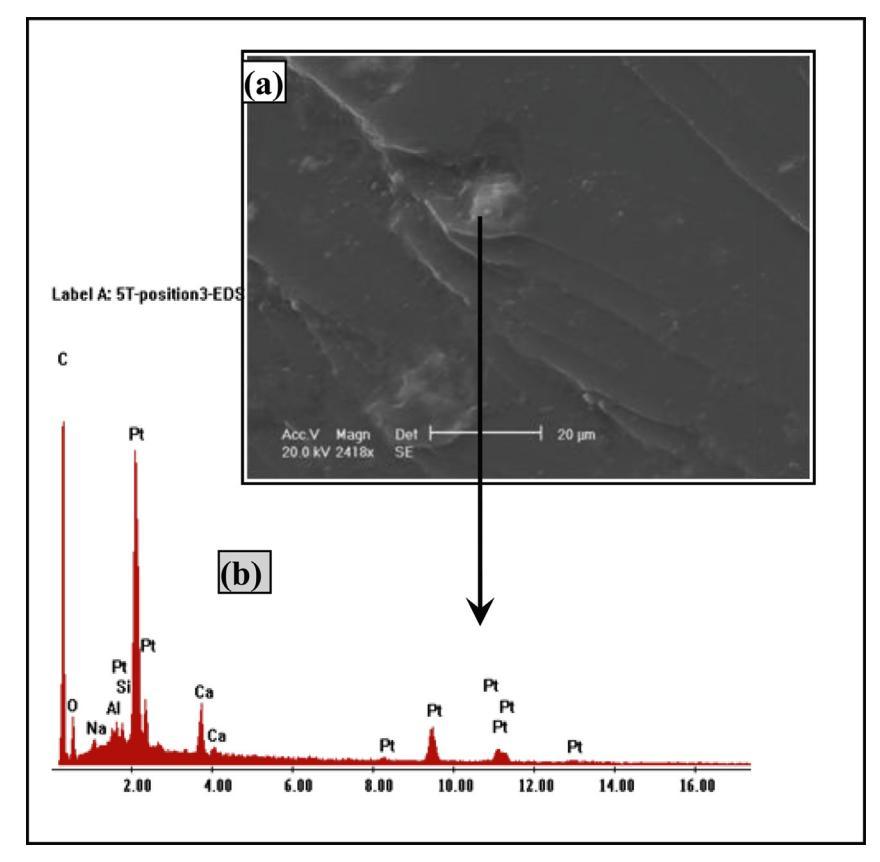
Fig. 6. SEM image of UPE/5 wt % s-HNT composite (a), and its EDS analysis (b).

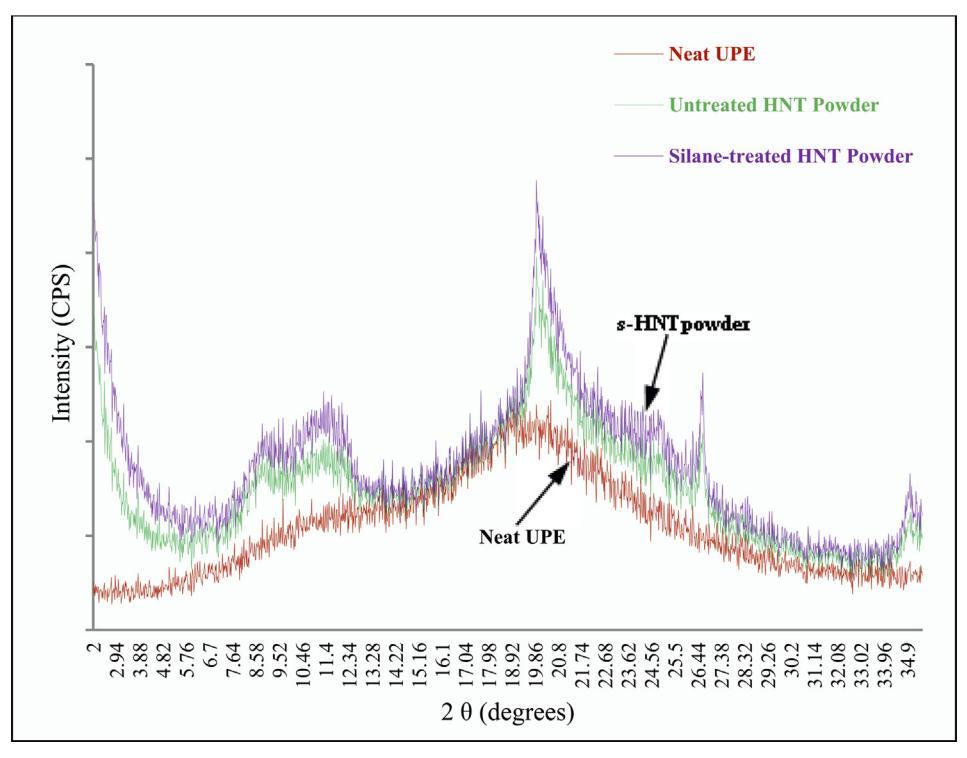
Fig. 7. X-ray scans for neat UPE, untreated HNT and silane-treated s-HNT nanotubes.

Wide-angle X-ray scattering (WAXS) scans of neat UPE, HNT and s-HNT loose powders are shown in Fig. 7. The XRD intensity pattern of neat UPE showed as a baseline diffraction pattern while the XRD intensity of HNT and s-HNT particles revealed a sharp basal reflection due to the random orientation of HNT. The treatment of HNT surface resulted in changing its crystalline structure and consequently higher order reflection peaks in the XRD patterns, indicating a high degree of nanotube orientation and high alignment of HNT tactoids in the flow direction. The basal spacing (001) of HNT and s-HNT were approximately similar at 7.42 Å, based on a diffraction angle of  $2\theta = 11.92^{\circ}$ and wavelength of Cu K $\alpha$  ( $\lambda = 1.54$  Å).

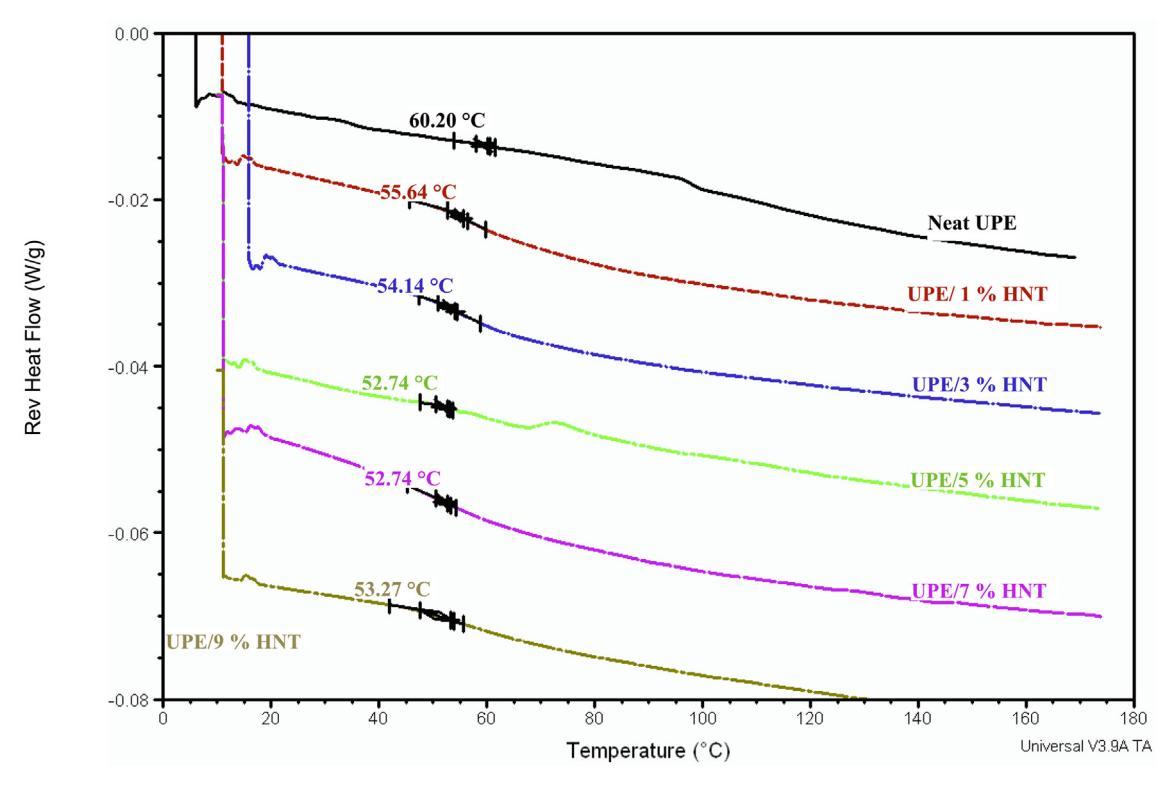
Fig. 8. DSC thermograms of neat UPE and its nanocomposites.

The role of HNT and s-HNT particles on the wettability and glass transition of nanocomposites was investigated by measuring the glass transition temperature (Tg) by using DSC spectra in the heating mode. The incorporation of HNT or s-HNT nanoparticles in the crosslinked UPE resulted in a marginal reduction in Tg values, with a slight shifting in the initial formulation of a giant molecule network of the UPE matrix, as shown in Fig. 8. The Tg values of neat UPE and its HNT and s-HNT nanocomposites are given in Table 1.

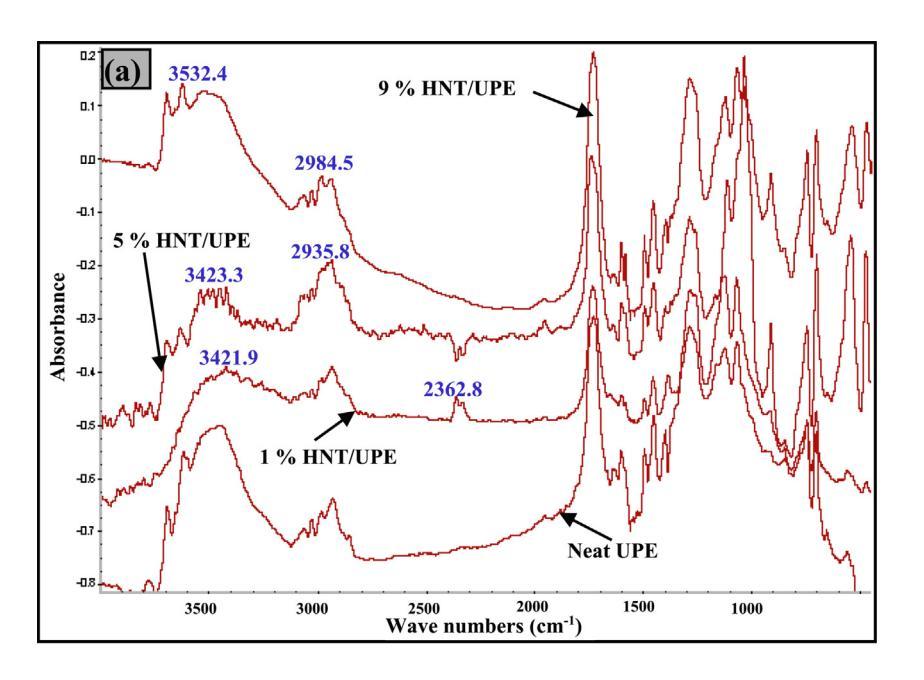
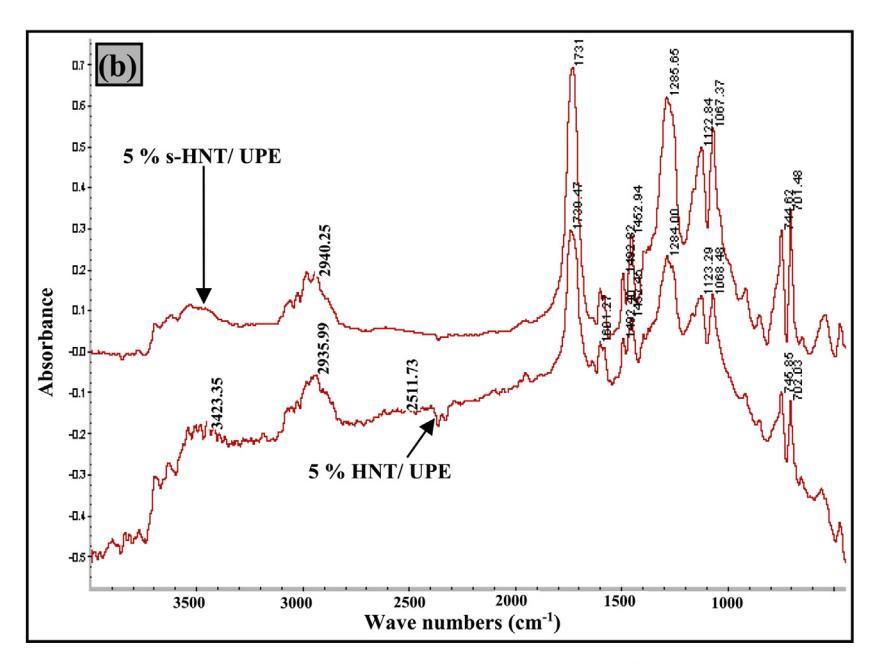
Fig. 9. FT-IR spectra of different HNT nanocomposites (a), and FTIR spectres for UPE/5% HNT and UPE/5% s-HNT nanocomposites (Comparison study).

Fig. 9 shows the FT-IR spectrum of neat UPE and its nanocomposites. Fig. 9a reveals the characteristic Si–O–Si absorption band occurred over a wide range of wave numbers in the region of  $701-1085 \text{ cm}^{-1}$ . Within the silanization process, hydrolysis and condensation reactions occur on bifunctional silane molecules [(RO)<sub>3</sub>SiCH<sub>2</sub>CH<sub>2</sub>CH<sub>2</sub>-X], leading to the generation of siloxane

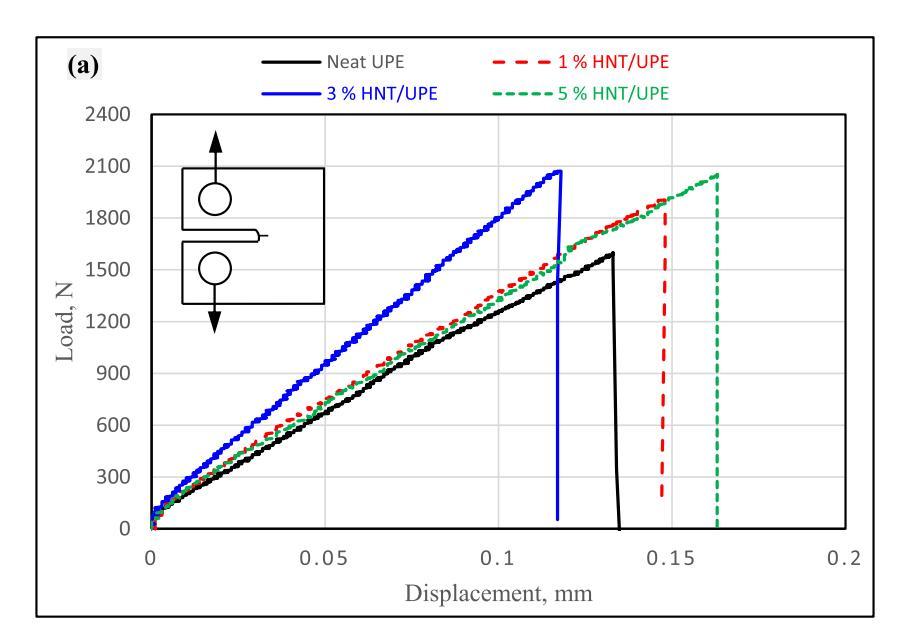
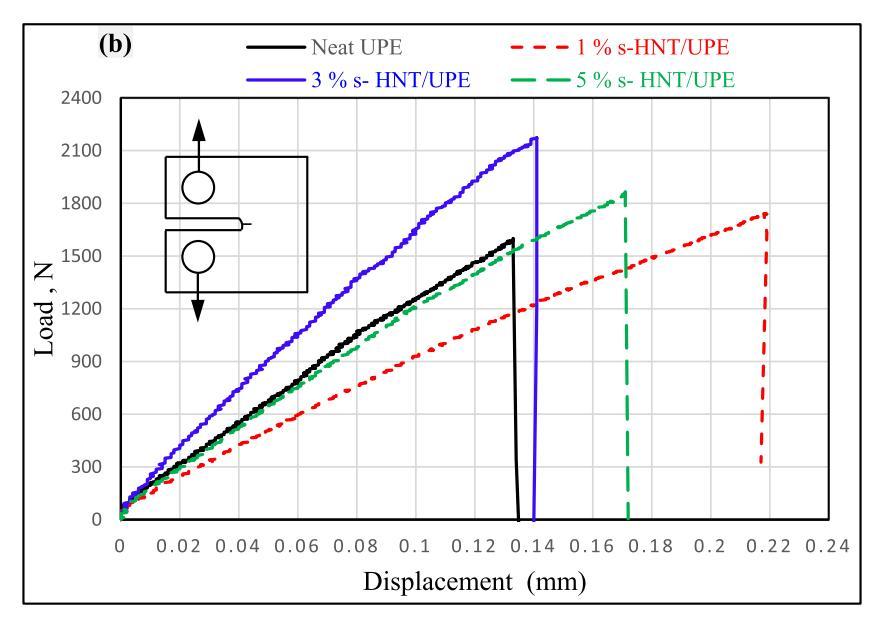
Fig. 10. Load-displacement curves of CT samples for (a) neat UPE and different UPE/HNT nanocomposites, and (b) neat UPE and different UPE/s-HNT fractured under tensile loads.

nanocomposites are shown in Fig. 10. In general, all nanocomposites tested in opening deformation mode (mode-I), using compact tension (CT) specimen geometry showed unstable crack propagation under a continuous loading condition, while the load dropped down to zero

The 3% HNT (Fig. 10 a) and 3% s-HNT (Fig. 10 b) nanocomposites showed their ability to carry higher loads. This is due to presence of plastic deformation in the UPE composites imparted by the well-dispersed halloysite nanotubes (shown in TEM images, Fig. 11a), blunting the crack tip and reducing the local stress concentration and consequently allowing composites to carry higher loads before failure occurs. The capability of 3% s-HNT nanocomposites is larger than that of the 3% HNT nanocomposites. It is obvious that the improved wettability and adhesion between the s-HNT nanoparticles and the polymer matrix as well as perfect uniform dispersion (shown in TEM images, Fig. 11b) resulted in higher fracture force and higher crack opening displacement (COD) compared to the untreated HNT ones. The values of fracture toughness ( $K_c$ ) and the critical strain energy release rate ( $G_c$ ) determined using two kinds of specimen geometries (CT and SENB) are listed in Table 1.

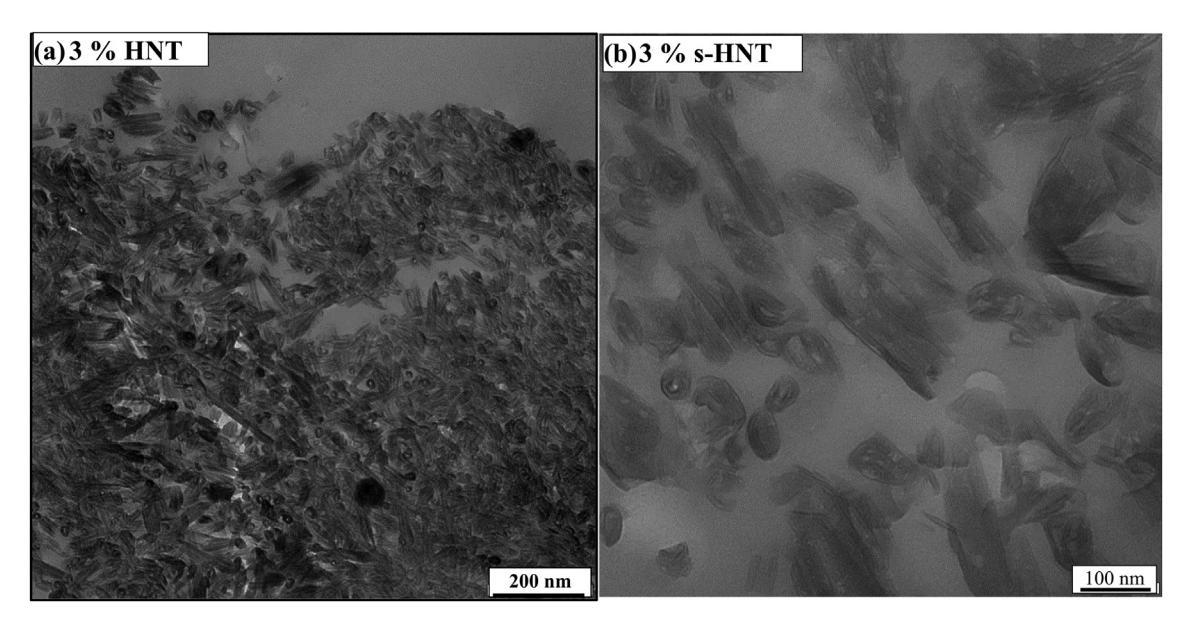
Fig. 11. TEM images of the cured 3% HNT-UPE composites (a), and the cured 3% silane treated HNT-UPE composites (b).

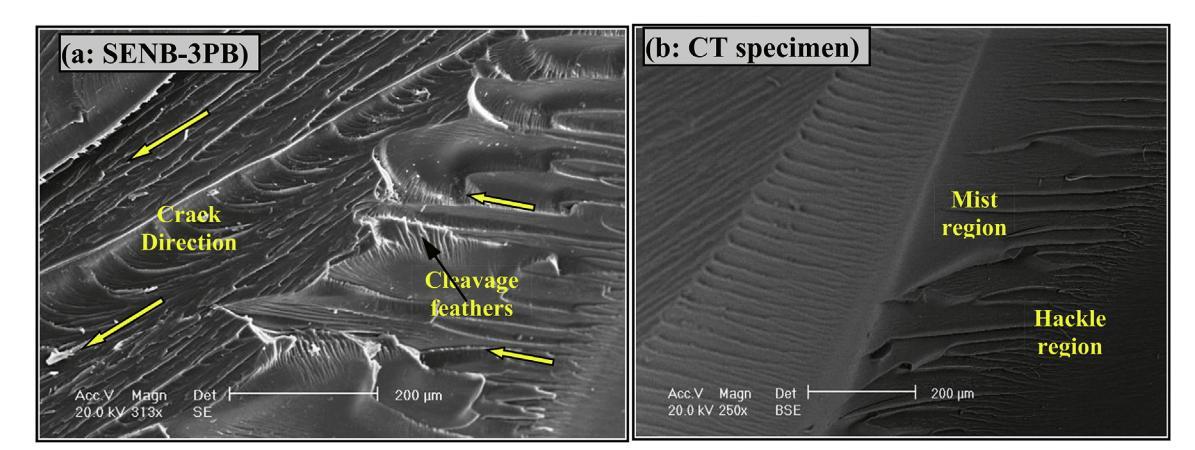
Fig. 12. SEM images of different fractured surfaces for unfilled brittle UPE matrix fractured under different loads and specimen geometries.

The fractoraphic analysis of the fractured-surface for unfilled UPE matrix tested with both the CT geometry under tension and the SEN-3PB under bending showed a highly smooth brittle fracture, as depicted in Fig. 12. The surface topography of the unfilled UPE matrix exhibited both smooth and rough surface features. The smooth one represented by mist regions while the rough surfaces represented by hackle regions (see Fig. 12 b). Hackle regions frequently appear in areas where the stress field (direction or magnitude) is changing rapidly or the stress state changes from plain strain to plain stress [27]. In the current case, the hackle regions appeared in the region of a specimen subjected to bending on the compression side of the specimen but changes to tension as the crack approaches from the tension side. Furthermore, different directions of crack propagation were observed in the morphology of the unmodified brittle UPE matrix irrespective the applied loads or specimen geometries.

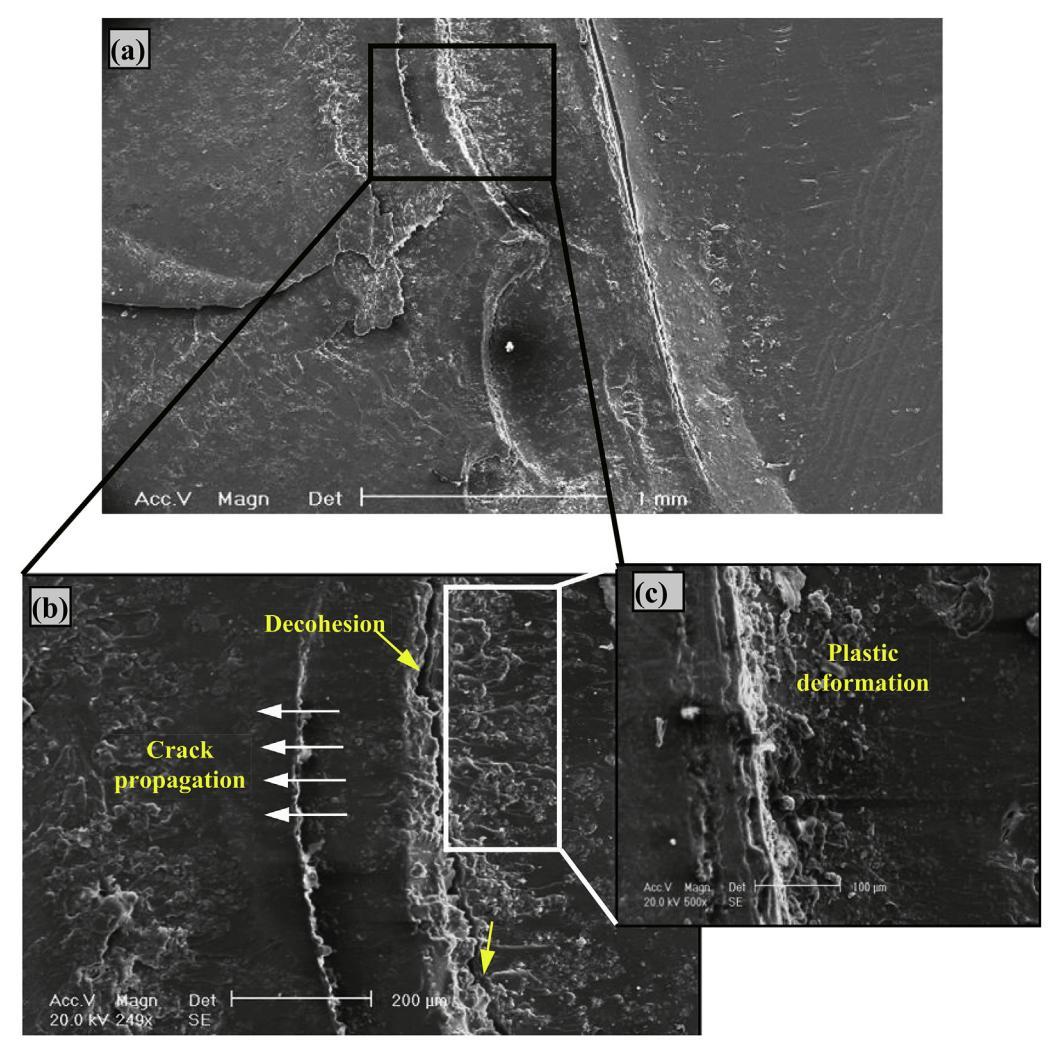
Fig. 13. Fractography of mode I fracture toughness using CT geometry for 5% HNT/UPE composite. The yellow arrows represent the decohesion and black arrows indicate the direction of the crack propagation. (For interpretation of the references to colour in this figure legend, the reader is referred to the Web version of this article.)

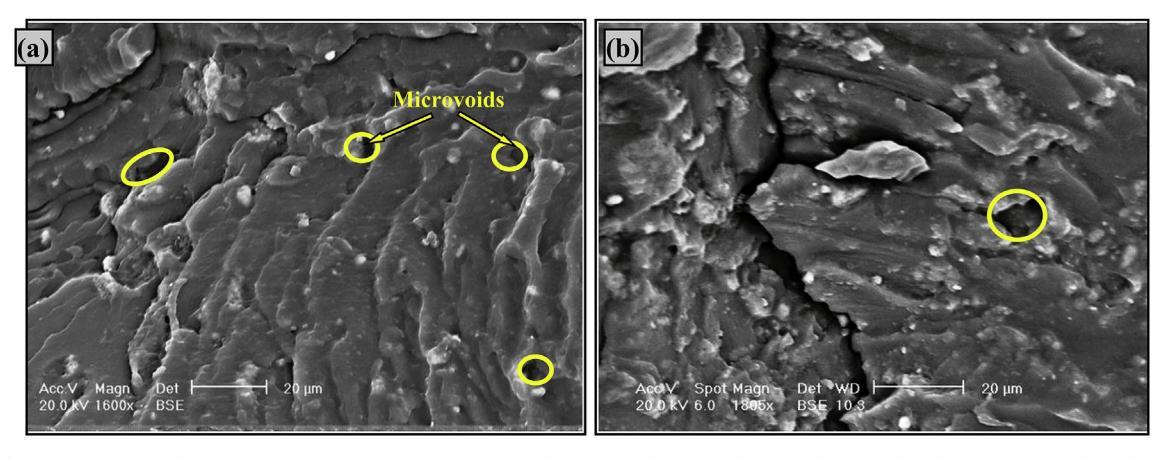
Fig. 14. Fracture surface for UPE/3% HNT composite showing the microvoids occurred due to the particle-polymer interface debonding.

The zone shielding toughening mechanism represented by the formation of micro-voids around the crack tip was observed as shown in Fig. 14. In general, there are three different mechanisms categorized under zone shielding mechanisms are: the transformation that occurs when the crack actually changes the crystalline structure of the surrounding material to inhibit crack growth; the microcrack formation and the crack field void formation [5]. Numerous micro-cracks or micro-voids form simultaneously in a brittle material when the applied loads reach a certain level. The distribution of these micro-cracks depends essentially on the local stress concentration and the material

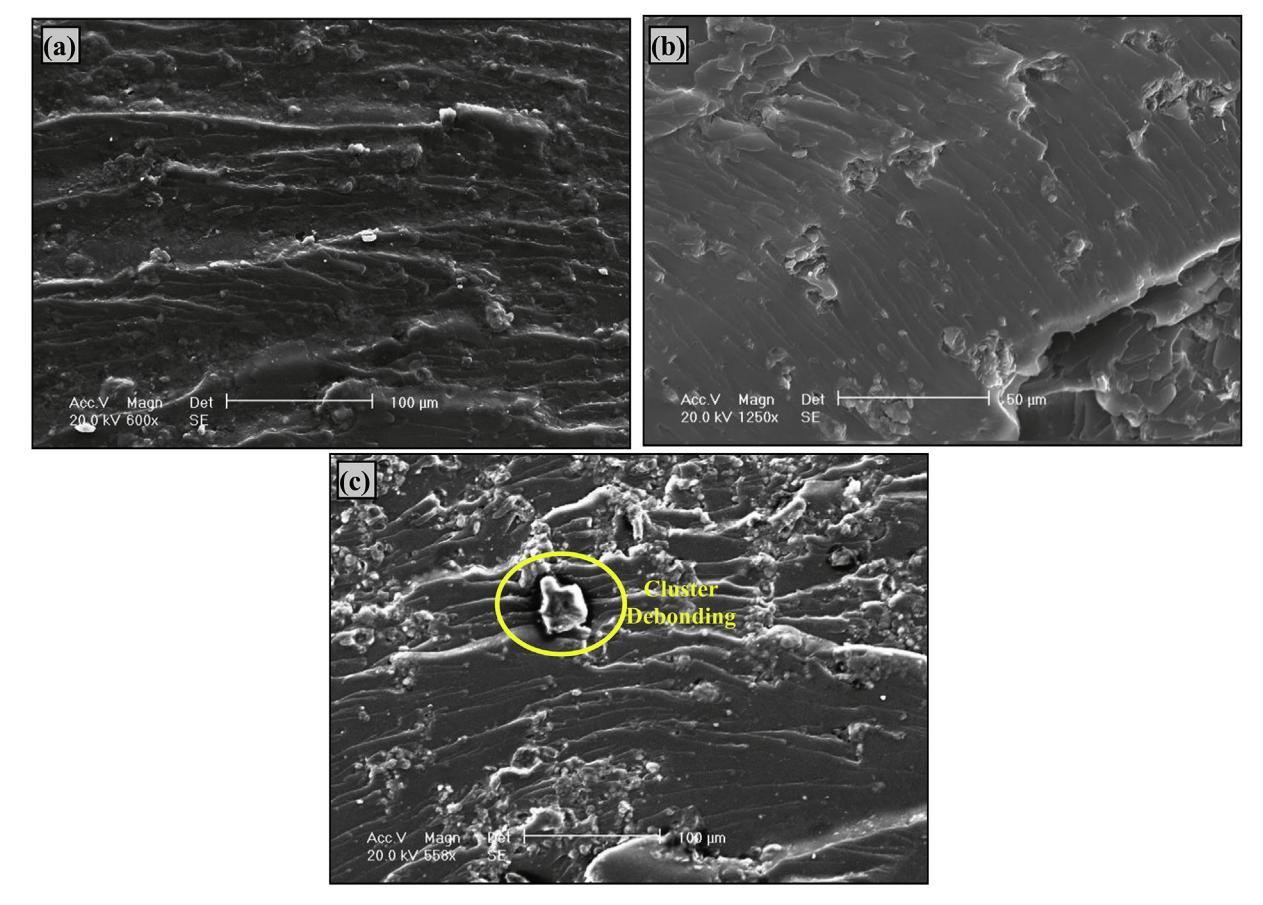
Fig. 15. Fracture surface of (a) 1% HNT/UPE composite, (b) 3% HNT/UPE, and (c) 5% HNT/UPE tested with the SENB geometry under bending, showing shear yielding mechanism.

The matrix shear yielding mechanism was observed in the fracture surface of untreated halloysite composite, as depicted in Fig. 15. This mechanism is also thought to be initiated by the stress concentrations around the periphery of the nanoparticles [21]. Furthermore, clear evidence of halloysite particle debonding can be found in the untreated

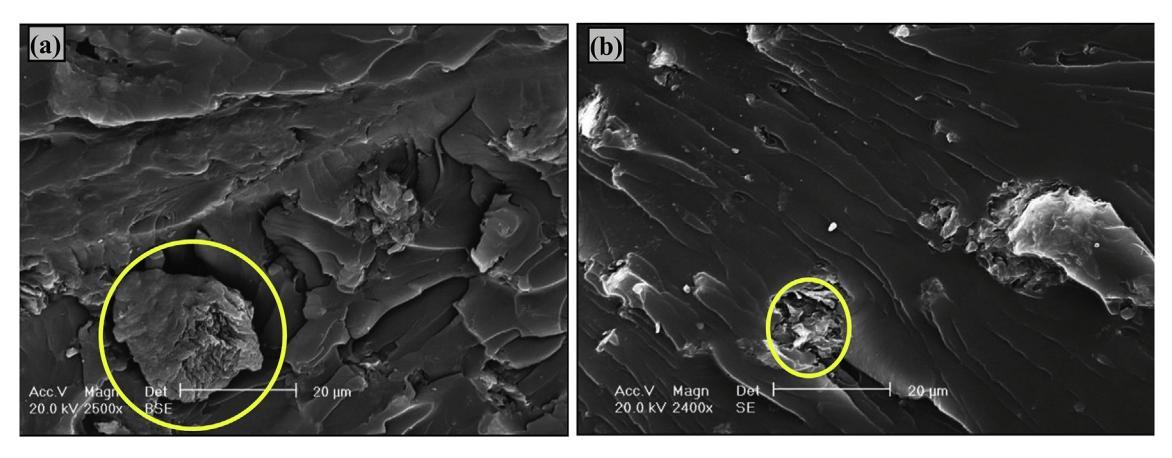
Fig. 16. SEM images illustrating the fracture surface of 3% HNT/UPE composite (a), and 5% HNT/UPE (b) after debonding.

system (Fig. 16 a, b), but not in the silanized system. On the fracture surface of the silanized nanocomposite, partially debonded or even fully debonded halloysite particles were found (Fig. 17 a, b), but much less commonly compared to the case of the untreated composite. Interestingly, contributing the total fracture energy, the presence of particles debonding considers one of the pre-requisites to activate void expansion and matrix shear deformation energy dissipation mechanisms [32].

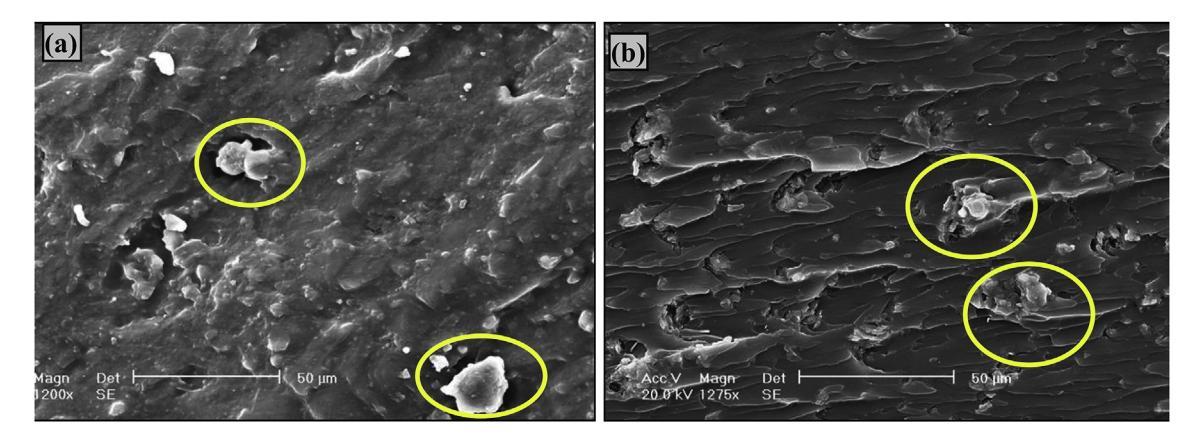
Fig. 17. SEM images illustrating the fracture surface of: (a) 1% s-HNT/UPE nanocomposite, and (b) 3% s-HNT/UPE nanocomposite after debonding.

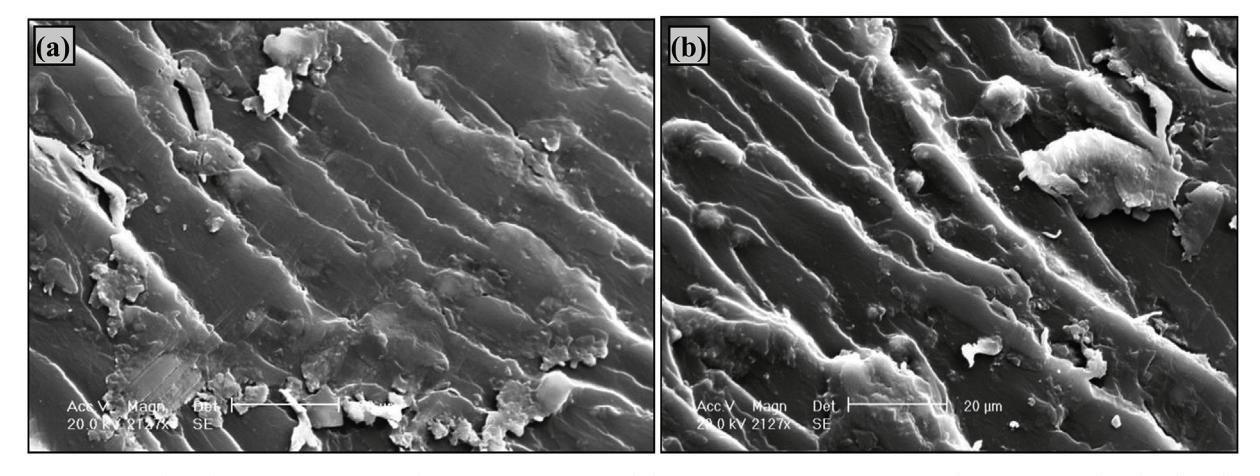
Fig. 18. Fracture surfaces from SENB geometries of: (a) 3% s-HNT/UPE, and (b) 5% s-HNT/UPE nanocomposite showing matrix shear band mechanism.

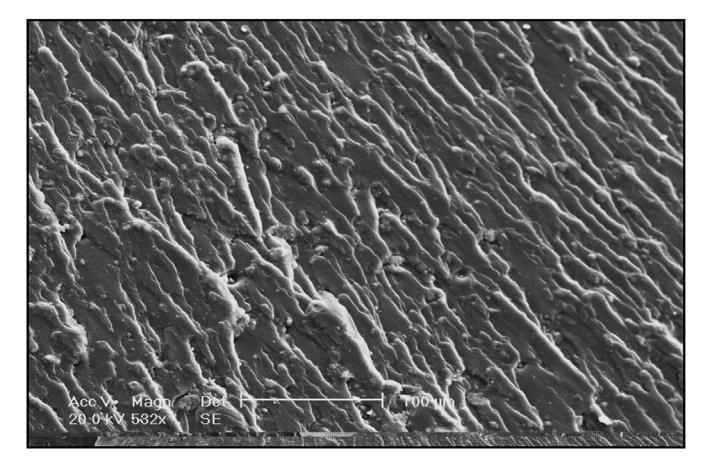
Fig. 19. Fracture surfaces from SENB geometry of 7% s-HNT/UPE nanocomposite showing the massive shear yielding mechanism.

In the view of the role of silanized halloysite (s-HNT) particles on the initiation of shear yielding, the higher contents of s-HNT caused in the initiation of the massive shear banding, as can be observed in the fracture surface of 7 wt % s-HNT nanocomposites, Fig. 19.

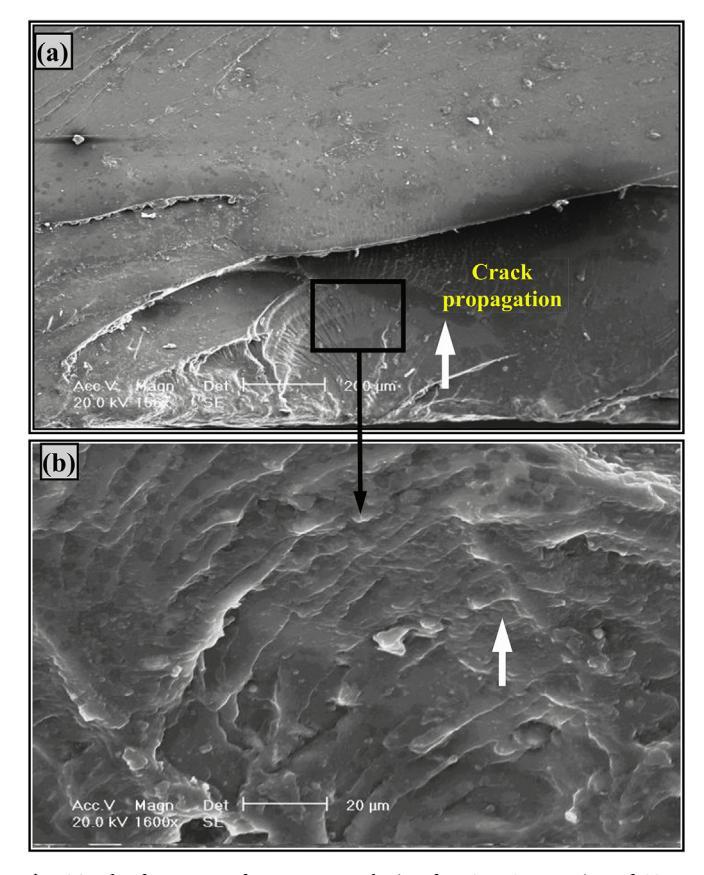
**Fig. 21.** The fracture surfaces near crack tip after SEN-3PB testing of 3% s-HNT/UPE composite, showing the crack initiation zone at different magnifications with a local deformation process. White arrows indicate the direction of crack propagation.

In light of the above findings and discussions, the fracture surface of 3% s-HNT/UPE nanocomposite after SEN-3PB testing showed a semicircular region of well-defined local plastic deformation process occurred around the crack initiation zone, as shown in Fig. 21. Such deformation process is to involve some toughness enhancement via blunting the crack tip and increase the size of the plastic zone. With further increase of silanized halloysite, instead of the occurrence of local deformation process in the crack initiation zone and crack propagation zone, river liner markings (Fig. 22) leading to the initial site of crack growth were detected in the topography of 5% s-HNT nanocomposite but substantial indications of plastic deformation in the control group were not noted. Hence, the lack of observed plastic deformation process and a smooth fracture surface agree well with the relatively low measured toughness of the nanocomposite. River pattern is a mechanism in which a pattern similar to a river and its branches are generated on the new cleavage plane at slightly different elevations. As the crack then propagated, these levels combined to form a crack advancing on fewer parallel planes [16].

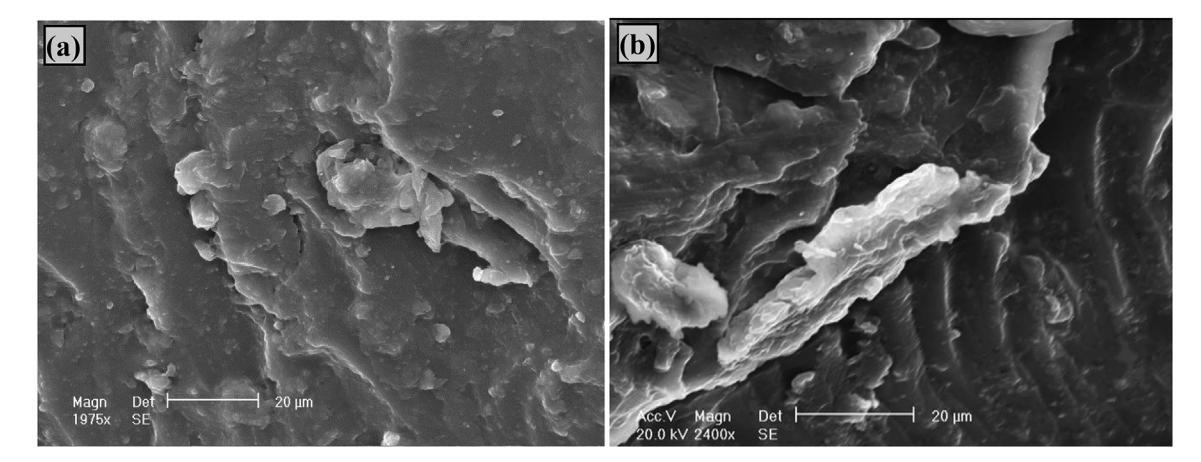
Fig. 20. SEM images of fracture surfaces near crack tip of (a) 5% s-HNT/UPE, and (b) 7% s-HNT/UPE nanocomposites showing crack bridging mechanism.

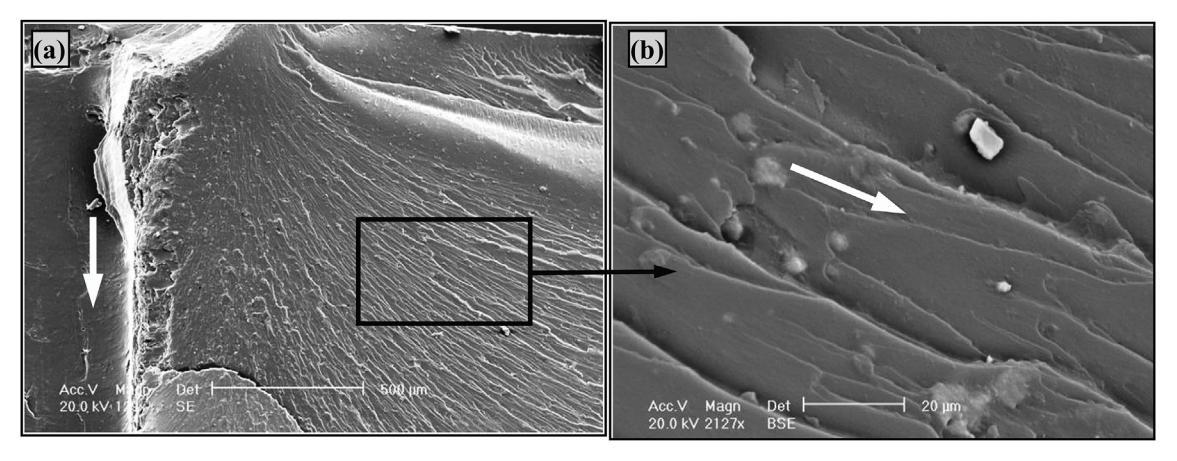
Fig. 22. The fracture surface of 5% s-HNT/UPE nanocomposite after SEN-3PB testing, showing crack initiation zone at different magnifications with river liners.

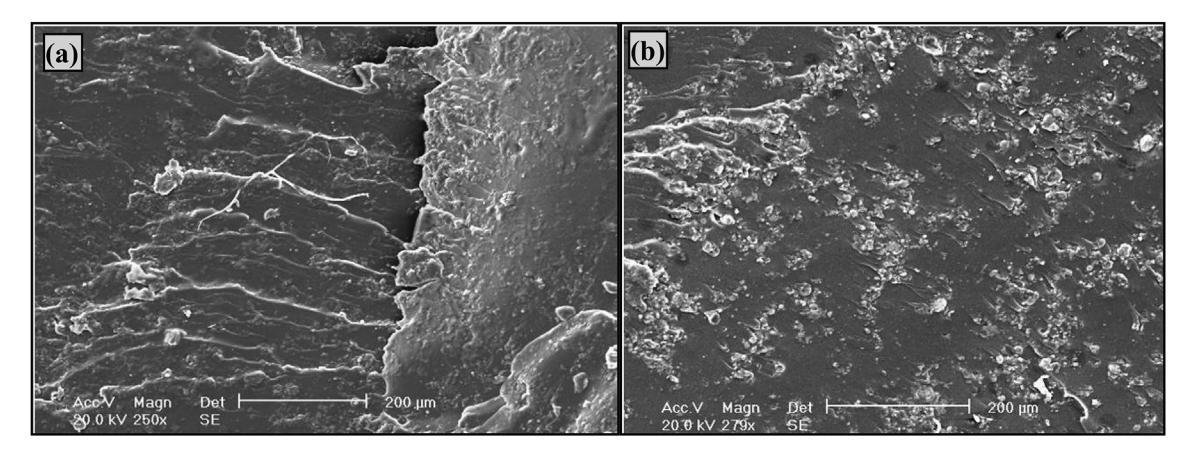
Fig. 23. The fracture surface of UPE reinforced with (a) 3 wt % s-HNT, and (b) 5 wt % s-HNT nanocomposites, demonstrating the tail-like structures.

Furthermore, characteristic tail-like structures formed behind halloysite aggregates in the process zone on the fracture surface can be observed in Fig. 23, which are often observed in particles filled epoxy systems [38,39]. The tail-like structures are in reality steps, which are formed when two secondary crack fronts divided by the aggregates meet with each other. With an increase of HNT content, the aerial density of these steps increases (see Fig. 23 b) and the fracture surface became rougher and more characteristic tails appeared and interconnected with each other (Fig. 24). The [40] suggested that characteristic tail structure usually forms when the two secondary crack fronts separated by a particle meet with each other after crack front bowing.

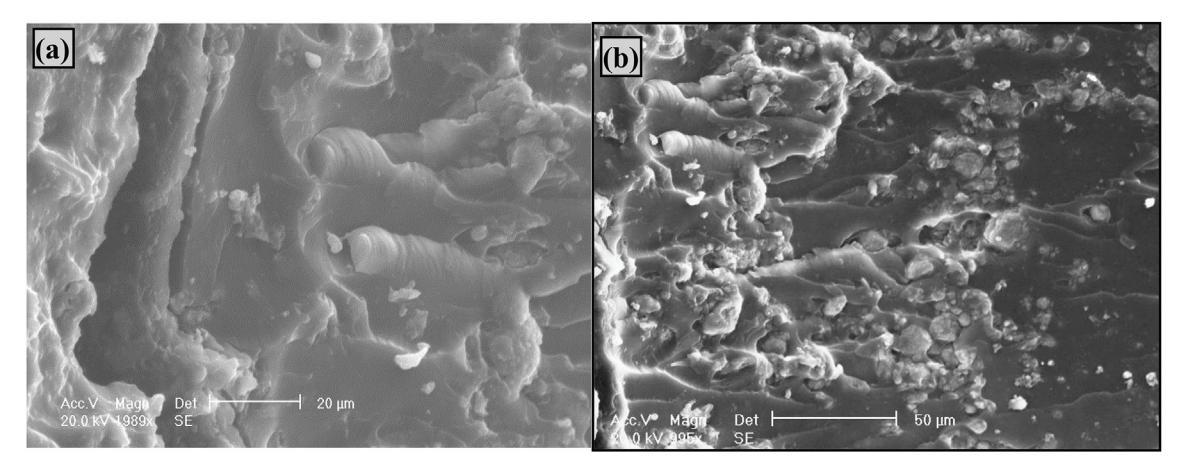
Fig. 24. Fracture surface morphology after SEN-3PB test of 5% HNT/UPE nanocomposite (a), and 5% s-HNT/UPE nanocomposite (b).

Nevertheless, there is no qualitative interpretation of Fig. 24 was found in the literature. The [41] claimed that a combination of well dispersed nanotubes with well impregnated smaller agglomerates leading to trigger void nucleation and/or micro-crack coalescences at the interface between nanotubes and the surrounding matrix resin. Later [42], reported that treated halloysite in the epoxy nanocomposite manifest small crack trajectories that are deflected and meander through the matrix, giving rise to the increased resistance to crack propagation. However, the particle agglomerates may also promote premature failure ahead of crack. Our point of view actually aligns with both observations where micro- and macro-cracks were found in the treated halloysite-unsaturated polyester composites, formed along the matrix-halloysite interfaces (see Fig. 25).

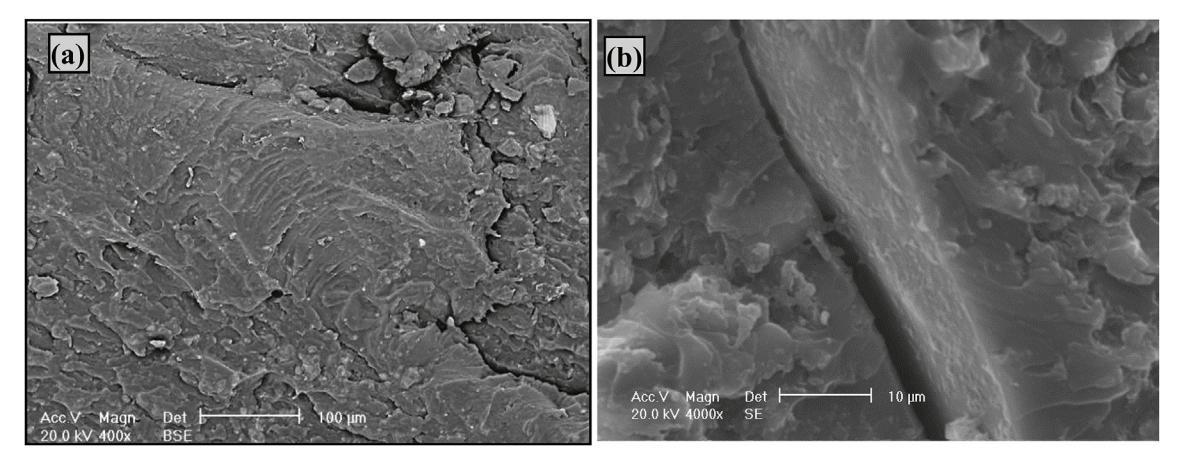
Fig. 25. Fracture surface morphology after SEN-3PB test of 5% s-HNT/UPE nanocomposite, showing macro-cracks (a) and micro-crack (b).

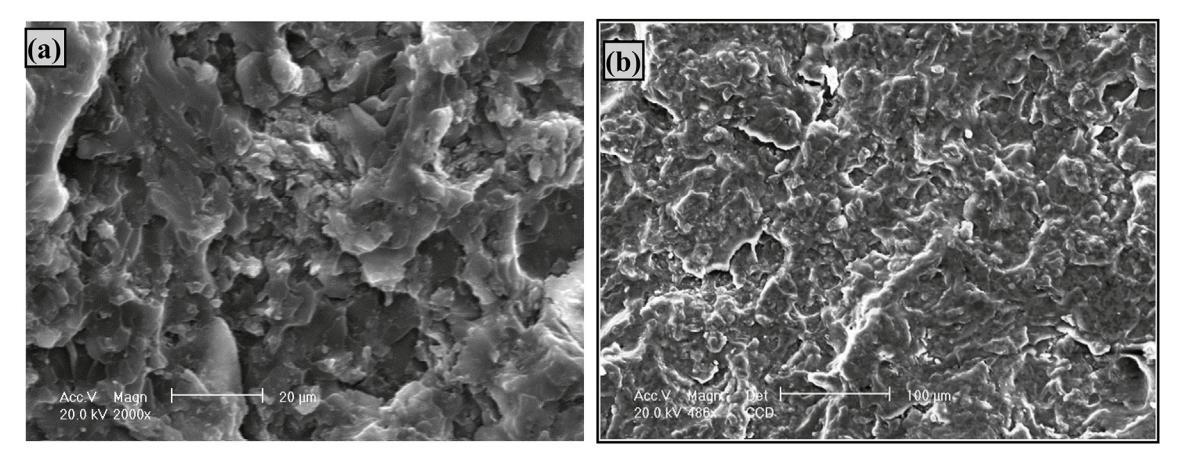
Fig. 26. The fracture surface for: (a) 7% s-HNT/UPE and (b) 9% s-HNT/UPE nanocomposites.

The situation of topography analysis (Fig. 26) is much complicated for nanocomposites containing higher halloysite contents where the fracture surface is very rough and filled with scale-like steps, indicating that the presence of halloysite layers forced the crack to propagate along a very tortuous path (see Fig. 26 a). This observation was supported by Ref. [25] where the curved path of crack growth can be due to the fact that the maximum tangential stress direction changes as the crack advances. At each step of crack propagation, the crack plane rotates and grows in a new direction that has the maximum tangential stress.
